## 4.0 EXISTING CONDITIONS

### 4.1 ENVIRONMENTAL

This section describes the existing conditions of natural and socioeconomic resources within the area affected by the Huntington Flood Damage Reduction Project. The description of each resource provides a baseline for measuring expected changes in the physical, environmental, cultural, social, and economic settings that would result from implementation of a flood damage reduction project in the study area.

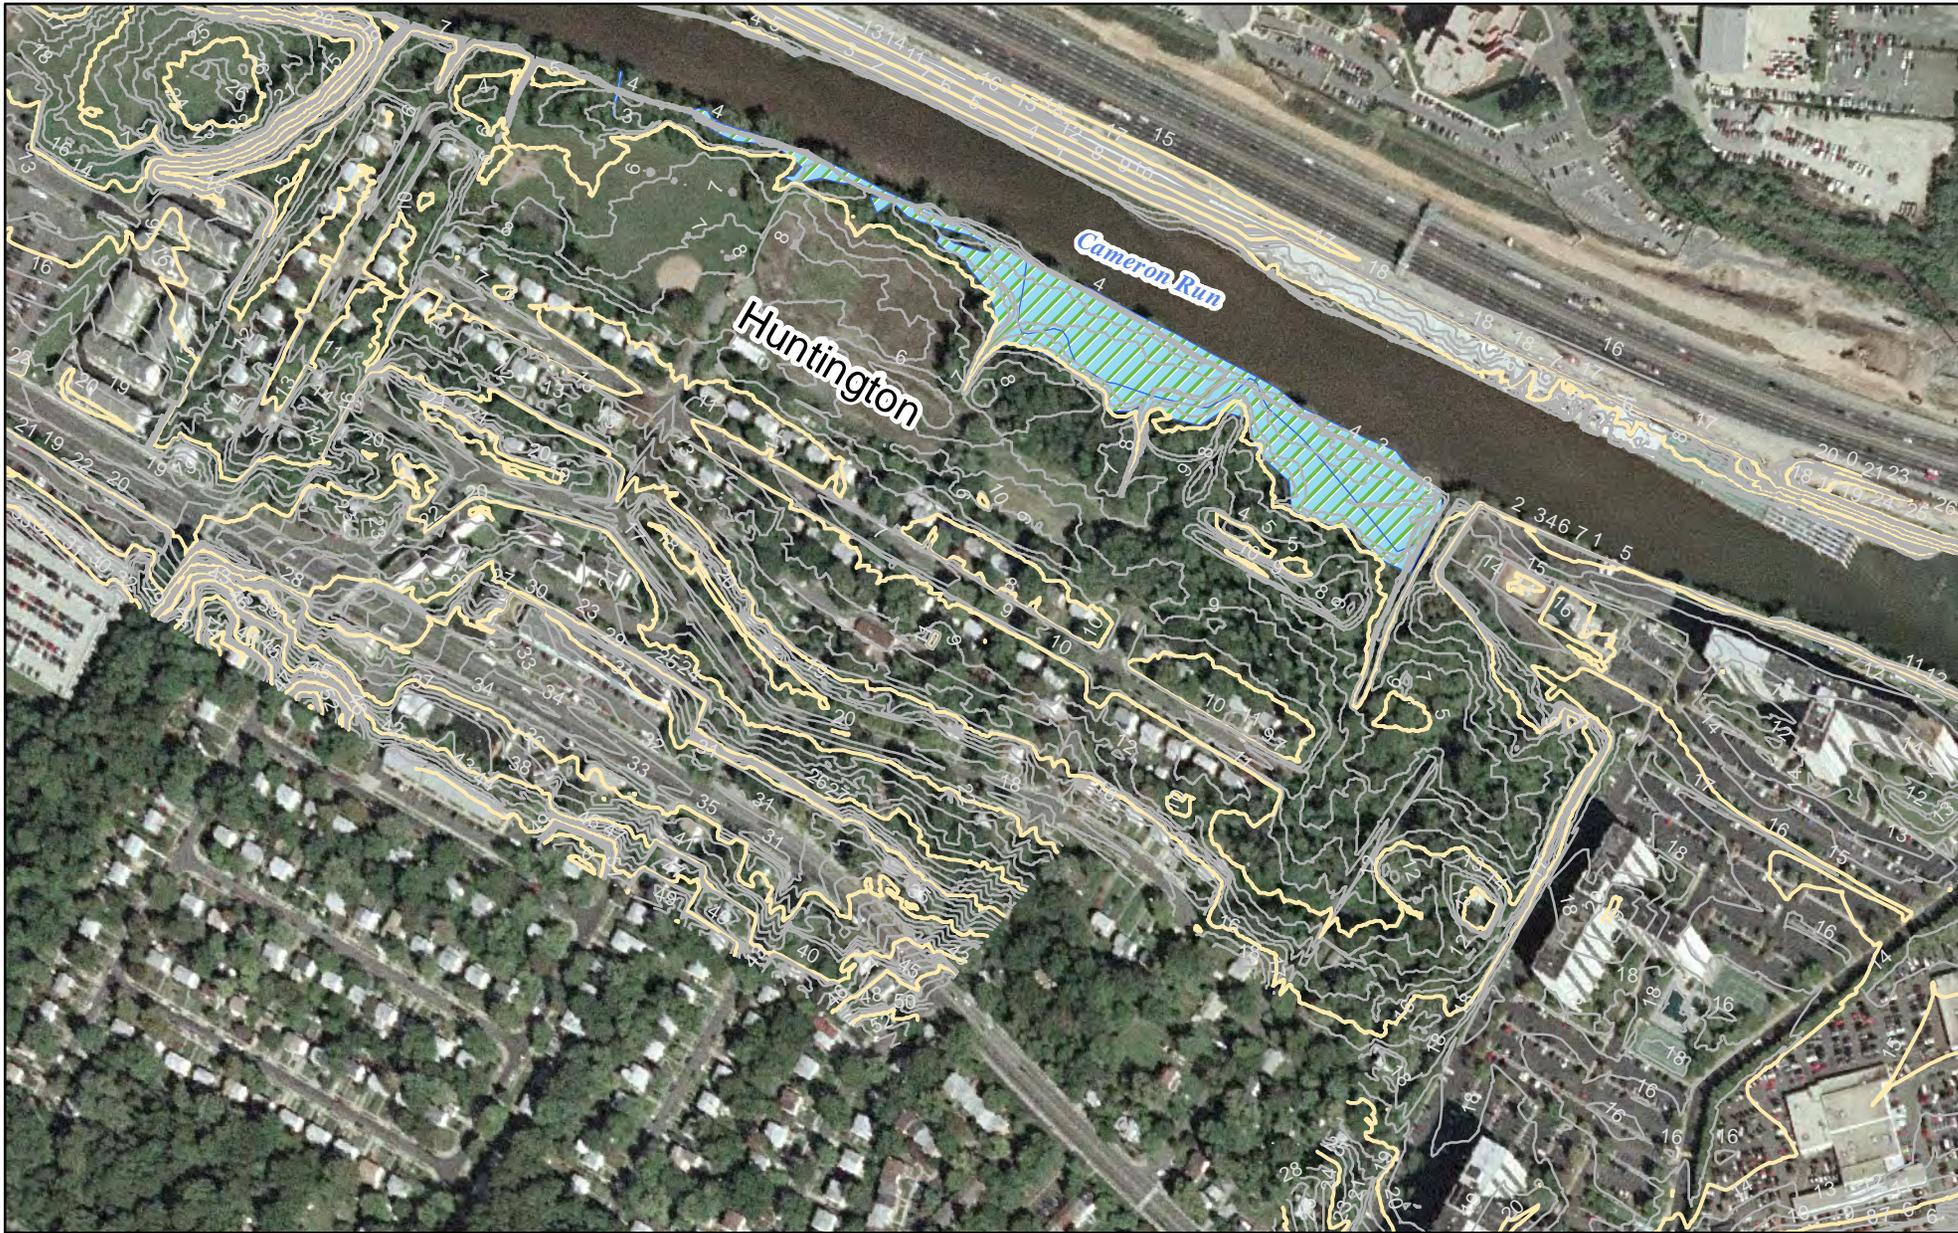
**Figure 4.1**

Topography and  
Delineated Wetlands

- One Foot Contours
- Five Foot Contours
- Delineated Wetlands, 2007

The elevation in the focus area ranges from almost sea level adjacent to Cameron Run and the Potomac River and reaches approximately 34 feet above sea level at the high point along Huntington Avenue (Fairfax County, 2004). The topography of the study area is mostly level and very gently undulating, but there are areas of rolling and hilly terrain near the river (Figure 4.1).

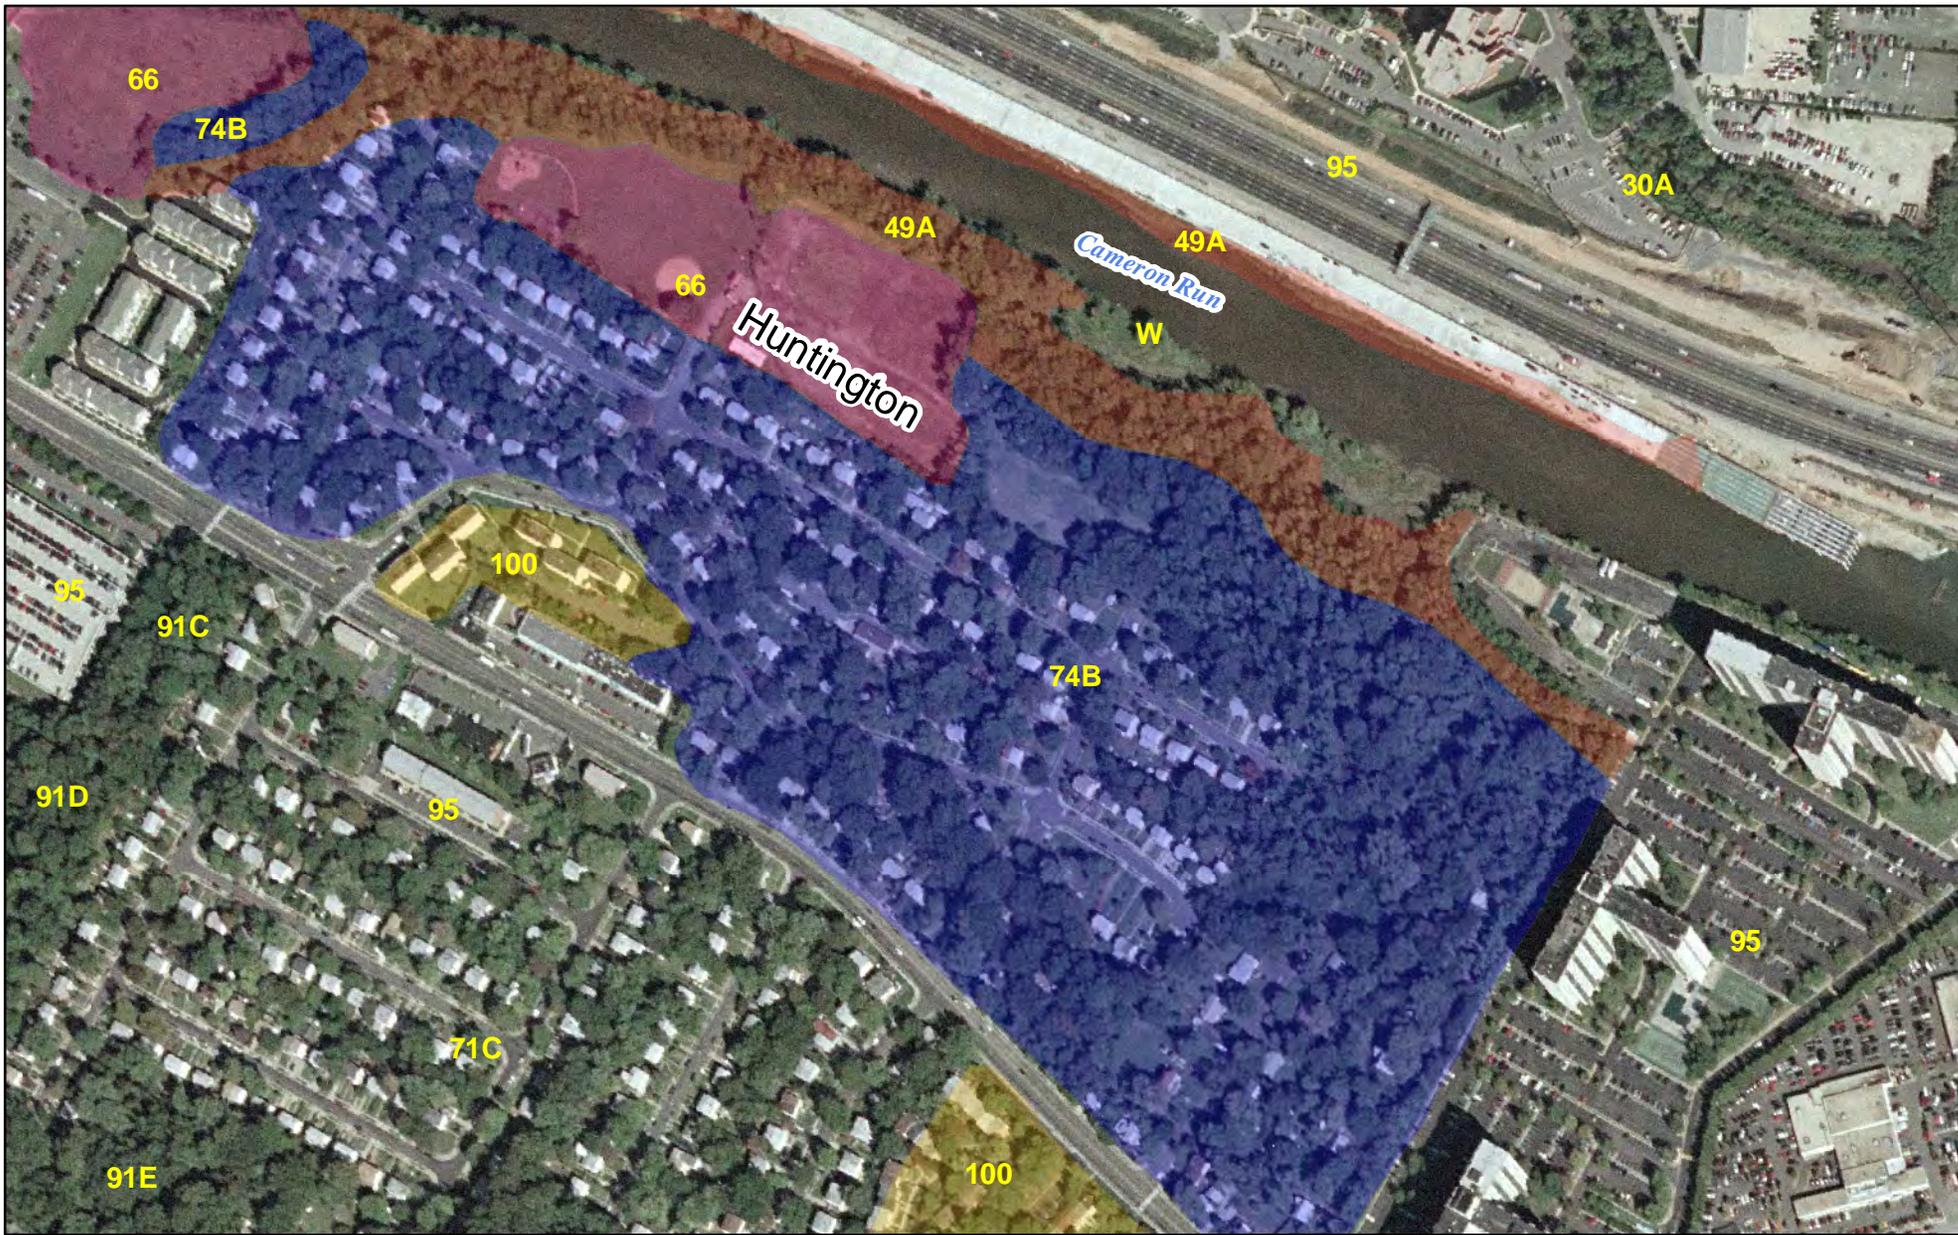
## Figure 4.2

Soils

- 49A - Hatboro Silt Loam
- 66 - Kingstowne Sandy Clay Loam
- 74B - Lunt-Marumsc Complex
- 100 - Urban Land-Kingstowne Complex

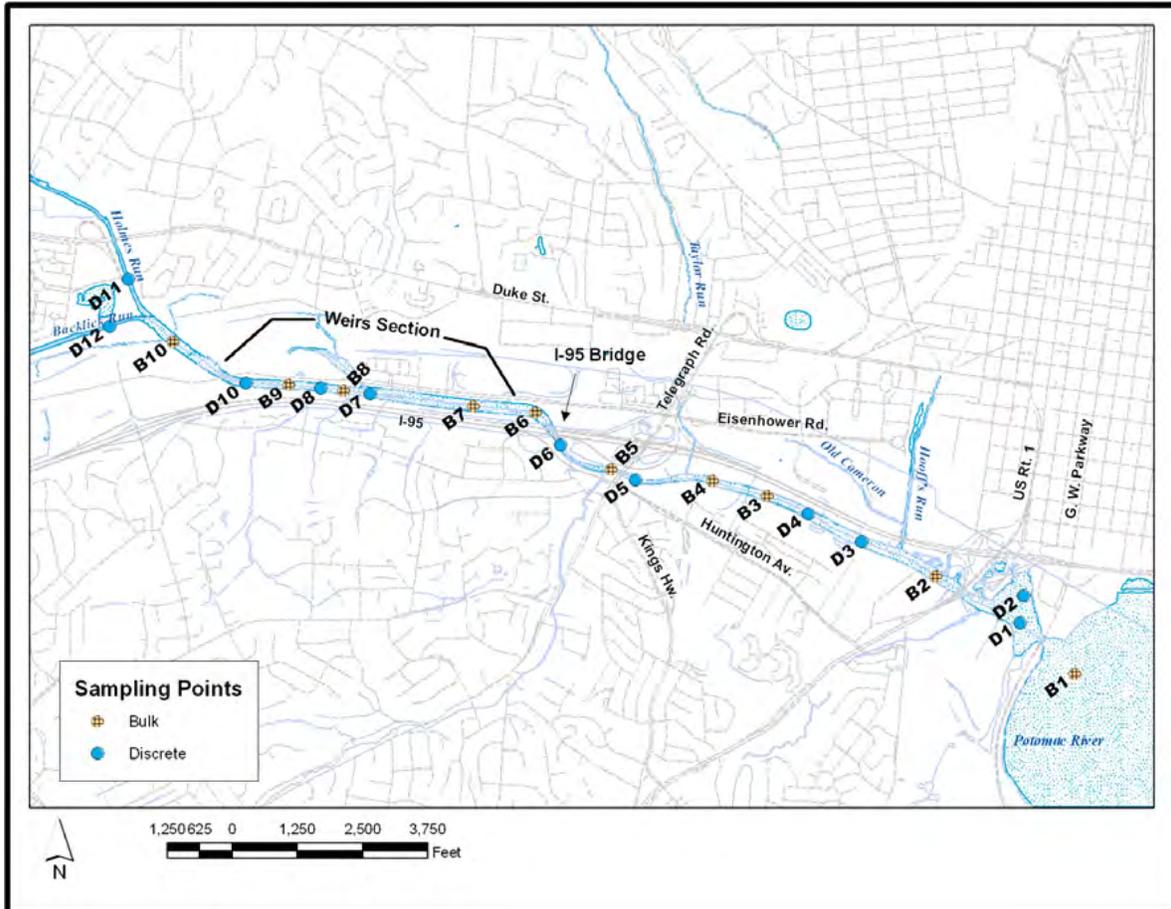
**Figure 4.4: Cameron Run Sediment Sampling Sites**

As part of the analysis, RK&K collected and analyzed thirty (30) sediment samples from twenty-two (22) sampling sites (from south of Duke Street to its confluence with the Potomac River). Sampling sites were chosen in order to capture significant changes in sediment gradation and characteristics throughout the study area (Figure 4.4).

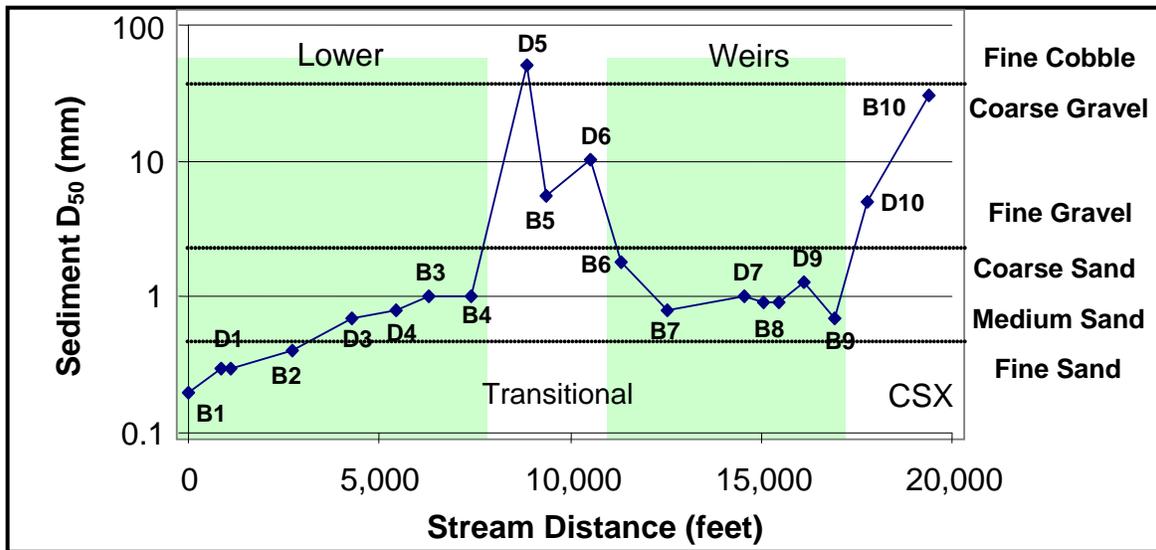
**Figure 4.5: Zones of Similar Bed Characteristics**

The  $D_{50}$  near the confluence of Backlick and Holmes Run was in the fine to coarse gravel range, while in the weirs area (just upstream of the Capital Beltway) the dominant particle size was found to be medium sand. However, instead of fining in the downstream direction, the  $D_{50}$  below the I-95 bridge crossing increases into the medium to coarse gravel range. These larger-sized particles (gravels, cobbles) continue downstream just past the Telegraph Road crossing, where a

large gravel/cobble bar has developed approximately 200-500 feet downstream of Telegraph Road. Sediment size becomes increasingly smaller in the downstream direction between the Metro Line (Yellow) and the Potomac confluence with  $D_{50}$  values in the fine to medium sand range. The Lower Cameron Run area is tidally influenced, however, the increase in particle size in the upstream direction is evidence of the diminished tidal influence near the Huntington area. See Figure 4.5.

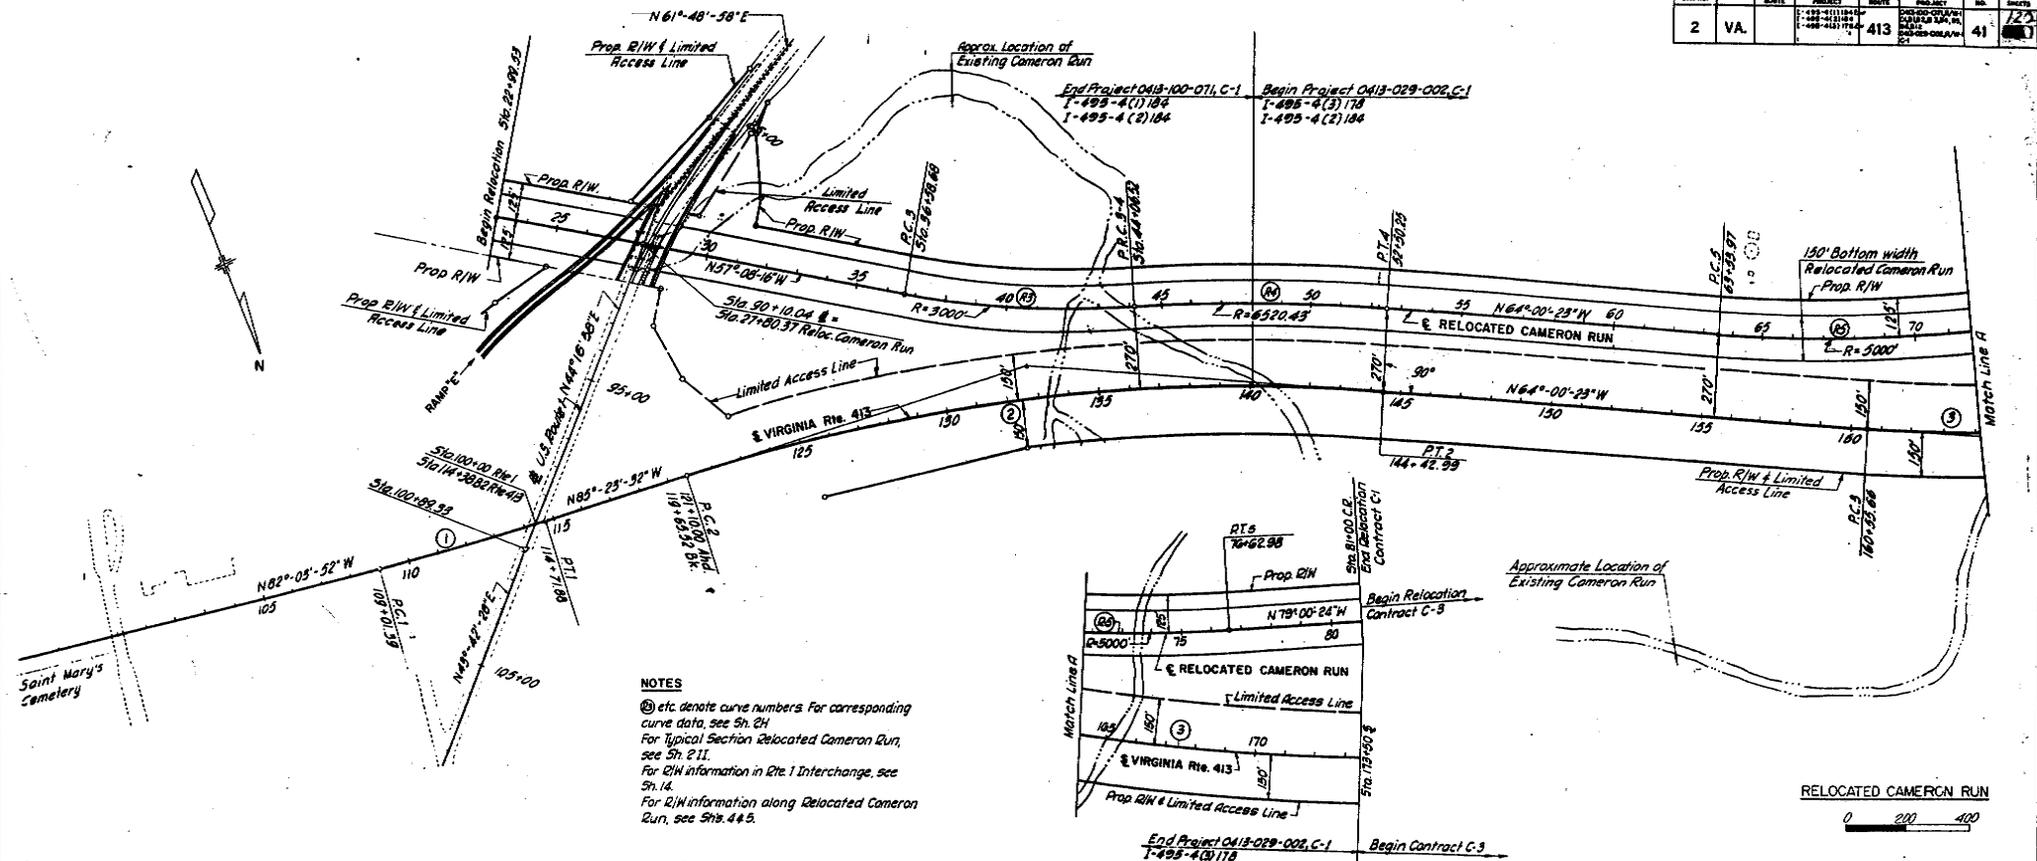
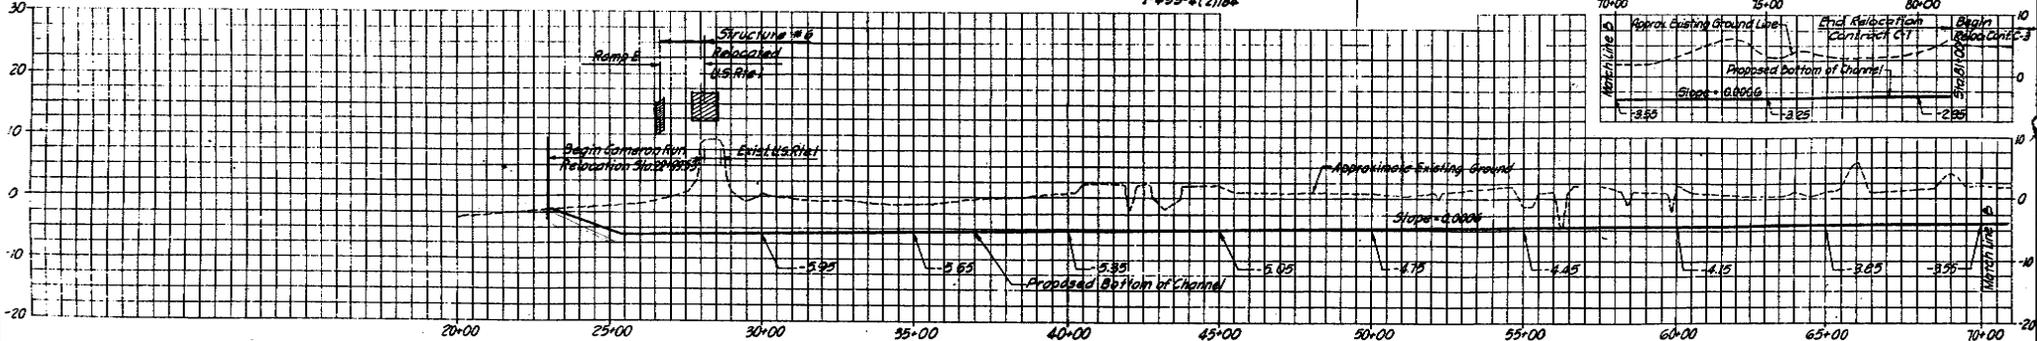
Figure 4.6 Capital Beltway Construction

After the sediment transport analysis was completed, a drawing from the construction of the Capital Beltway (I-495) was obtained (Figure 4.6). It shows how Cameron Run was rerouted for the construction of the beltway in the early 1960's, and how the new channel tied into the existing natural channel just south of the Route 1 interchange. At the tie-in point, the channel has an inverted slope; the channel bed slopes up approximately 4-5 feet higher, essentially creating a sediment trap. This could have contributed to the accelerated accumulation of sediment in this reach in the 1960's and 1970's.
